Re: Reconnaissance Inspection, April 23 and 25, 2012
Portions of the Quebrada San Antón, Quebrada Juan Méndez, Río Piedras River, Puerto Nuevo Canal, Quebrada Doña Ana watersheds
Municipality of San Juan ("MSJ") Municipal Separate Storm Sewer System ("MS4") Permit (PRR040036)
PRASA Puerto Nuevo Wastewater Treatment Plant Collection System (PR0021555)
Puerto Rico Department of Transportation and Public Works (DTOP) MS4 Permit PRR040080

**Compliance
Evaluation
Inspection:**

Municipality of San Juan Municipal Separate Storm Sewer System
("MS4") Permit (PRR040036)

Inspection Date: April 23 and 25, 2012

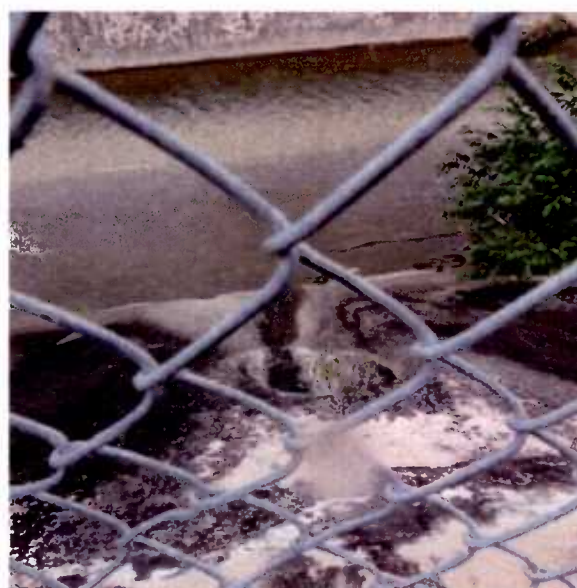
DSCN0009.JPG

As shown in photographs 9 and 10 (Attachment 1) there was a trickle of dry weather flow discharging into the west side of Quebrada San Antón from the outfall. This discharge was identified in the 2009 CSA Report (see Attachments 2b.2 - 2b.4) as R15c-S001a indicates that MSJ should verify whether there is a possible connection with the sanitary system at this location. Maps of the area indicate that this outfall is within the Municipality of San Juan.

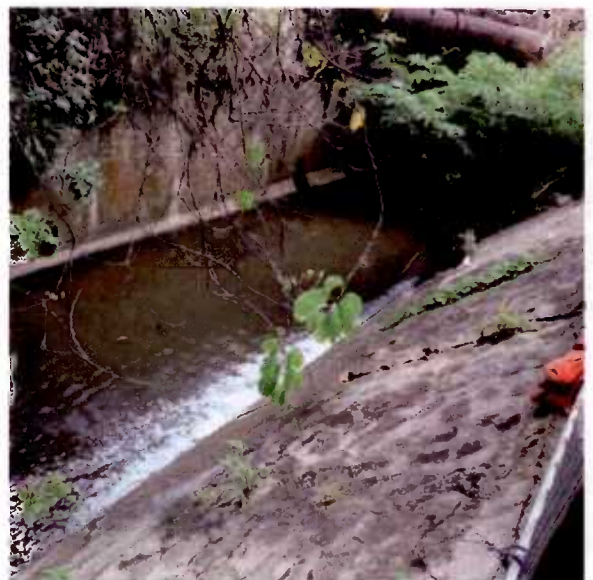
DSCN0042.JPG

As shown in photographs 42, 44 and 45 there was a discharge from a sewer pipe located behind/east of 1232 Nicolas Aguayo into the west side of the Quebrada San Antón. There was a significant flow from the outfall and some slight foaming at the discharge. Ammonia screening samples taken by EPA recorded ammonia levels between 0.5 and 1.0 mg/l and a pH of about 6. (Image 43 is a video of this discharge as well). Screening for illicit connections and determining the source of the flow is necessary.

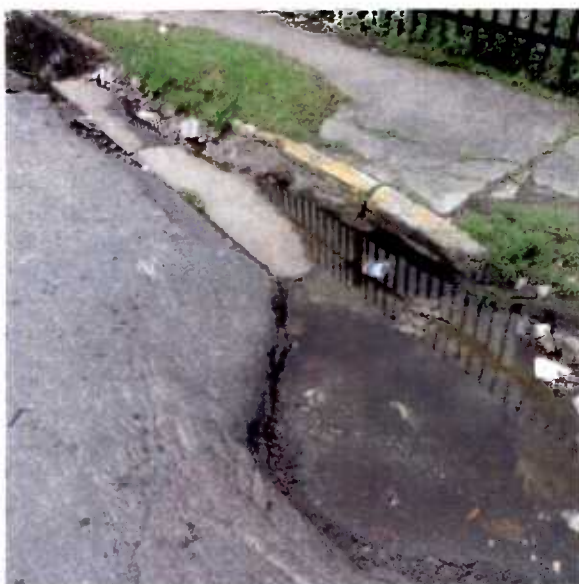
DSCN0052.JPG

EPA verified that the sanitary sewer overflow that was seen at this location in February 2012 had ceased. However, the catch basin at this location needed to be cleaned (see photographs 52 and 53).

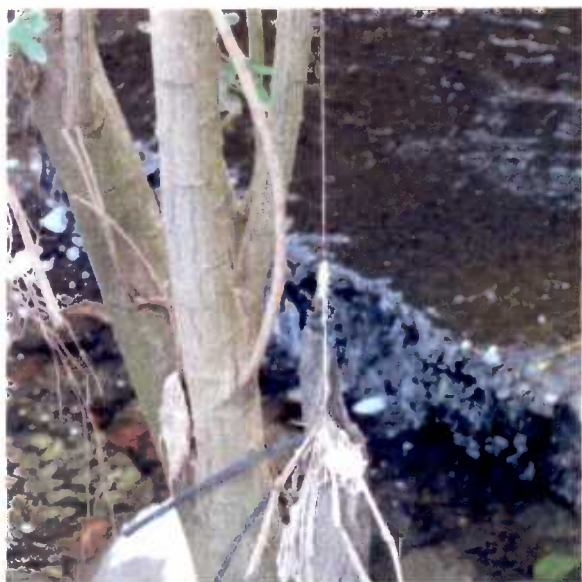
DSCN0097.JPG

As shown in photographs 87, 88 and 90 there is a dry weather flow from a large round sewer pipe into the Quebrada Doña Ana, northwest of the Jesús T. Piñero Bridge over the Quebrada (east of Calle Andalucía). As shown in photograph 86 there are hypochlorite feed tanks located above this outfall that are no longer in use. Photograph 90 shows that there is a small (approximately <1", white PVC line) that is broken and water is coming out of this line and entering the large round sewer and flowing into the Quebrada. If this is a broken water line, it should be removed to prevent backflow from the outfall and Quebrada during high water. Screening samples at this outfall had ammonia levels of approximately 0.5 mg/l and a pH of 6.5 to 7.0 SU. MSJ and PRASA must determine the source of this discharge and if there are sources of non-allowable non-stormwater.

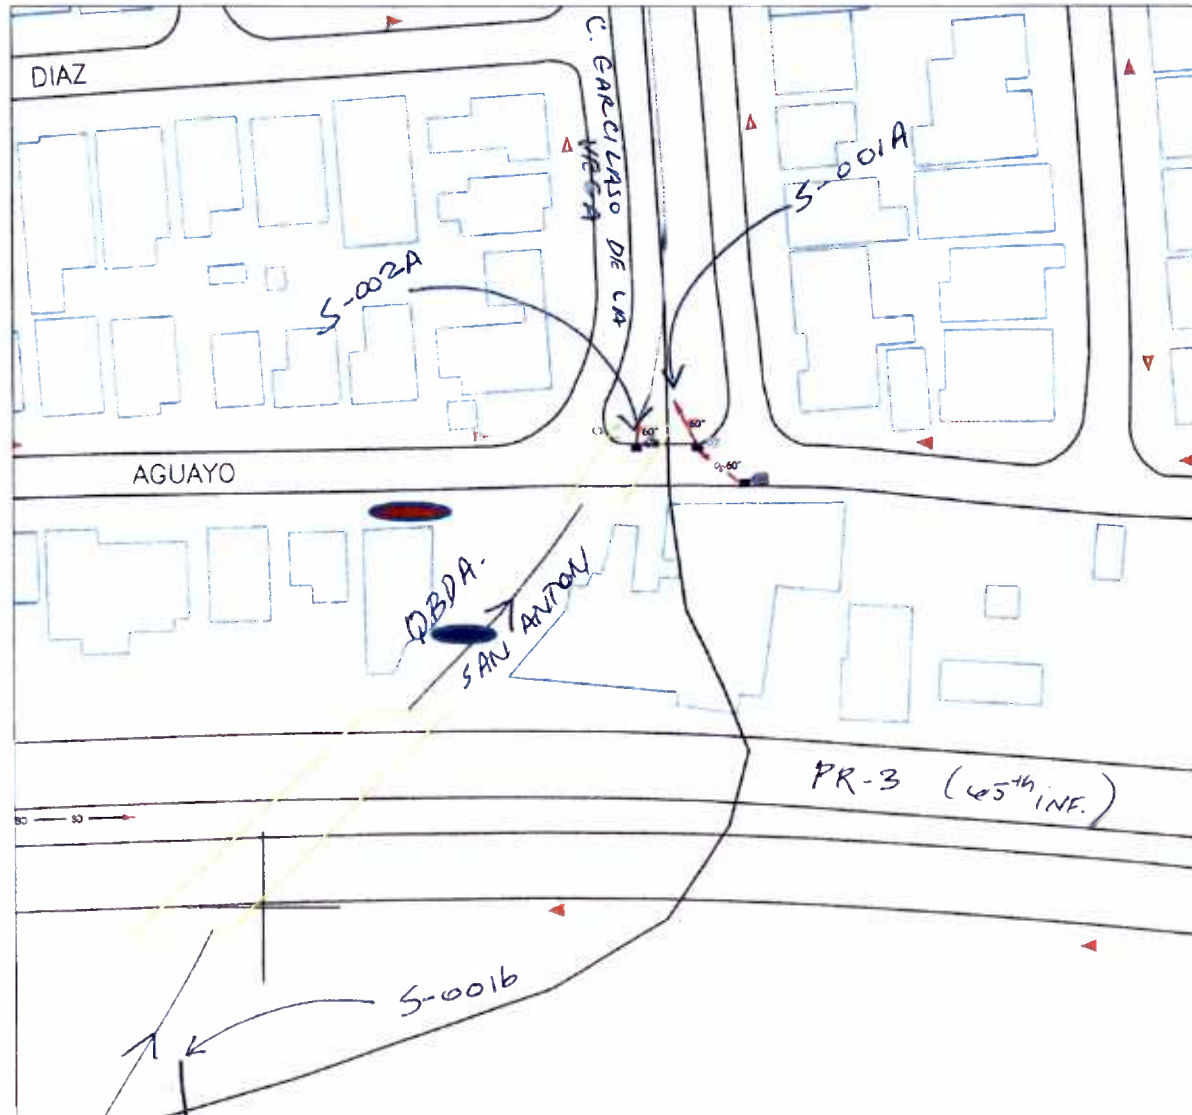
2d-2, - R18b – S001a – 2009 CSA Report Sabana Llana Comandante – Q. San Anton
S001a – Nicolas Aguayo – Note S-001A is not in San Juan, but within Carolina

Sanitary Disch. on
Sidewalk in front of
1232, Nicolas Aguayo
(See paragraph B.7 of
Recon report)

Discharge pipe with dry
weather flow to Queb.
San Anton from behind
house at 1232 Nicolas
Aguayo
